### NORTH CENTRAL MICHIGAN COLLEGE PETOSKEY CAMPUS

### Facilities Conditions Assessment Mechanical And Electrical Petoskey, Michigan

PBA Project No. 2019.0114.00

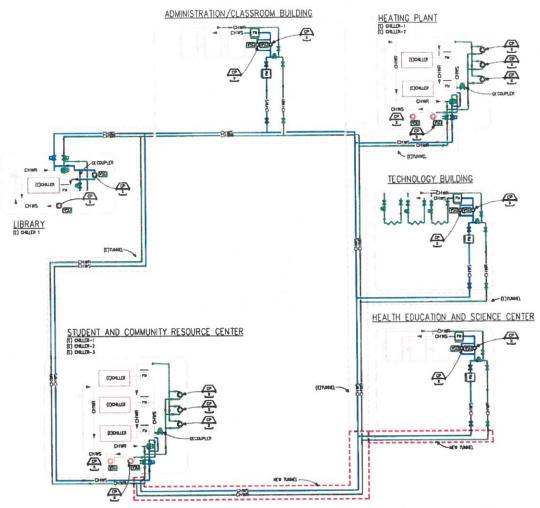
PROPOSED CAMPUS DECENTRALIZED CHILLED WATER LOOP SCHEMATIC DIAGRAM NO SCALE

The campus cooling system is currently configured where each campus building has its own individual cooling system. If a chiller fails for any reason cooling is lost to the

building (no back up). In addition, the individual building chillers do not modulate and are cycled to maintain cooling set points as a result the cooling system is less efficient and produced additional wear to the equipment.

- Potential electrical cooling energy saving 20%-30%.
  - Provides redundancy in campus cooling systems.
    - If a campus chiller fails another chiller connected to loop will provide cooling.

- No cooling down time to conditioning campus buildings.
  - Extends life expectancy of chilled water equipment.
  - Reduced maintenance.
  - Improves cooling controllability throughout campus.
