NORTH CENTRAL MICHIGAN COLLEGE **2019 MASTER PLAN**

2019 -2023

October 29, 2019

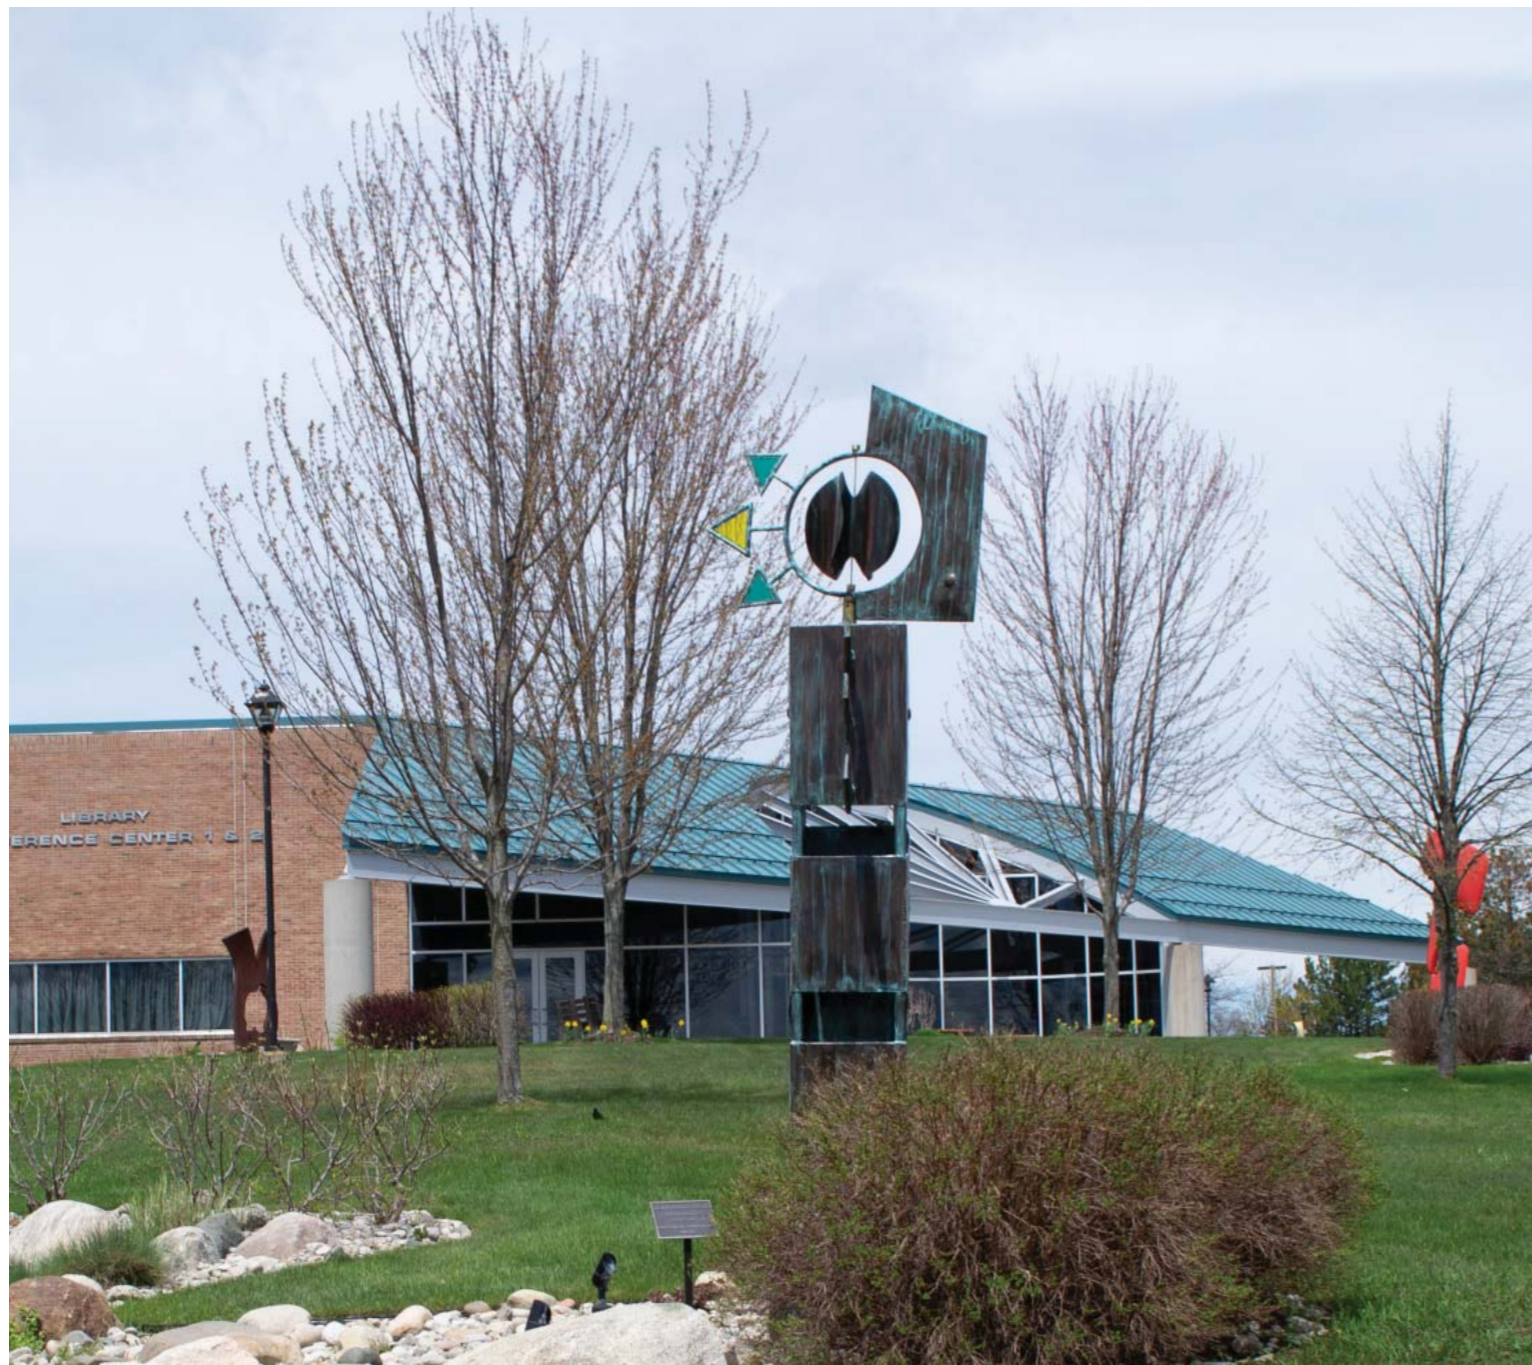
Campus Map

1. Administration/Classroom Building (AD/CL - Rooms 100-160 and 19-70)
 - University Center (UC - Lower Level)
2. Heating Plant
3. Maintenance Building
4. Technology Building
 - TECH - Rooms 218-230
5. Jack and Dorothy Harris Health Education and Science Center (HESC)
 - CHEM - Rooms 303-312
 - BIO - Rooms 320-340
 - Nursing/AH - Rooms 346-368
 - Greenhouse
6. Student and Community Resource Center (SCRC)
 - Bookstore (Room 530)
 - Learning Support Services (LSS - Room 533)
 - Recreation Facilities
7. Residence Hall
8. Student Center Cafeteria (Iron Horse Café)/Conference Center 3&4
 - Student Services (Rooms 503-512)
 - Corporate and Community Education (CCE - Room 536)
9. Library/Conference Center 1&2
10. Early Childhood Education Building (ECE)
11. Natural Area

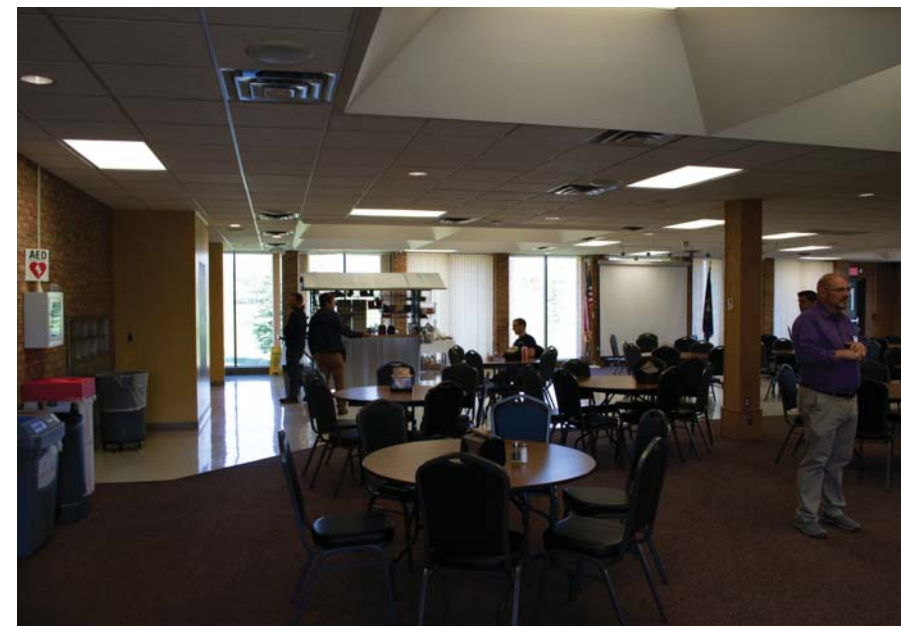
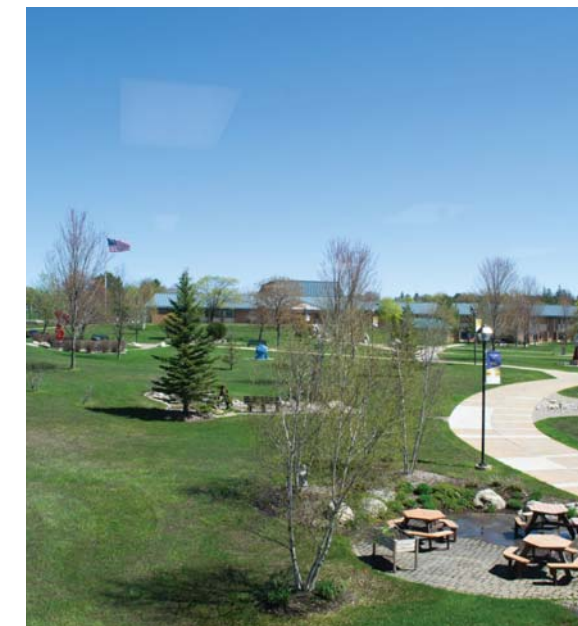
Student Center Cafeteria (Commons) IRON HORSE CAFE

The Student Center Cafeteria was constructed in 1967. The building is 20,000 square feet consisting of general use facilities and office areas. The building is sited on the south side of campus and is connected on to the Student and Community Resource Center on the east. Nearby parking is found in Lot #5.

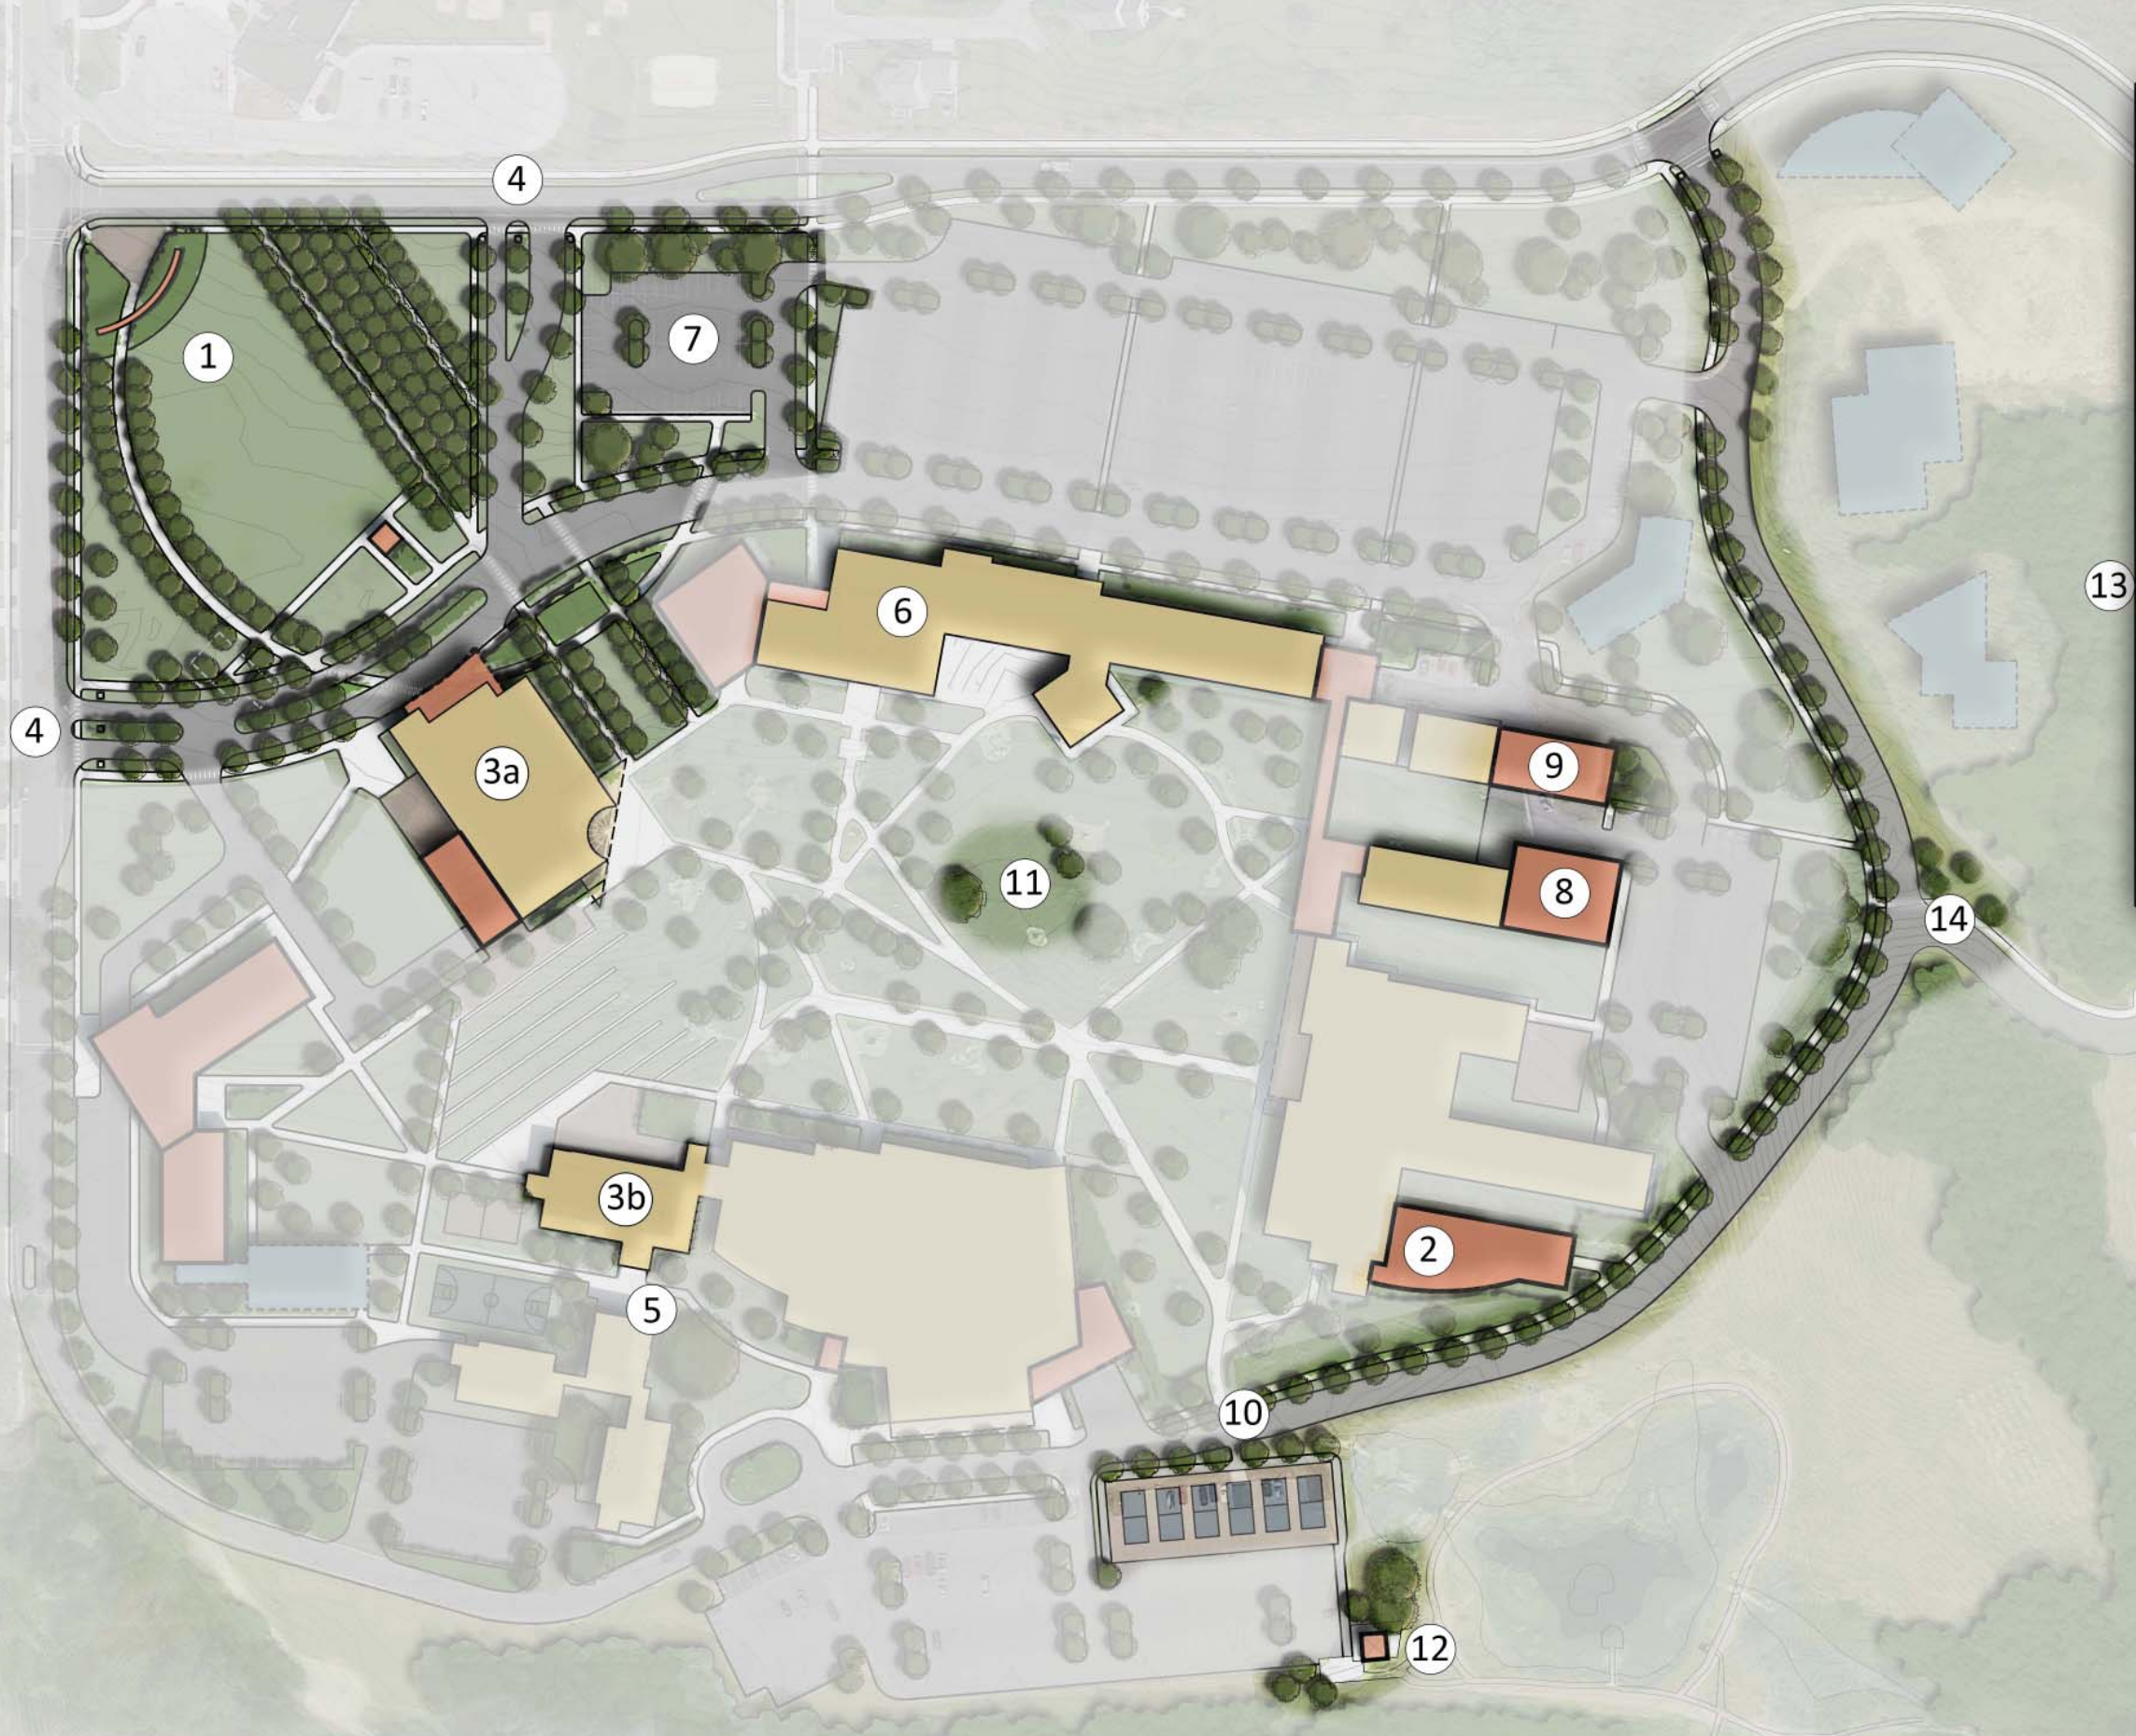
- 1-5 YEAR FACILITIES PRIORITIES**
1. Develop Iconic Identity Signage at Atkins & Howard
 2. Provide a new addition for the Nursing program
 - 3a. Renovate the Library into a multi-use, multi-functioning Student Innovation Center building

- 3b. Renovate the former Iron Horse Cafe and vacated Student Services areas into a new Multi-Media Resource Center.
 4. Create new identifiable Campus entry/exit points off of Howard & Atkins. Combine with a drop-off lane at the Library/Multi-Use Building. Demolish former Early Childhood Education structure.

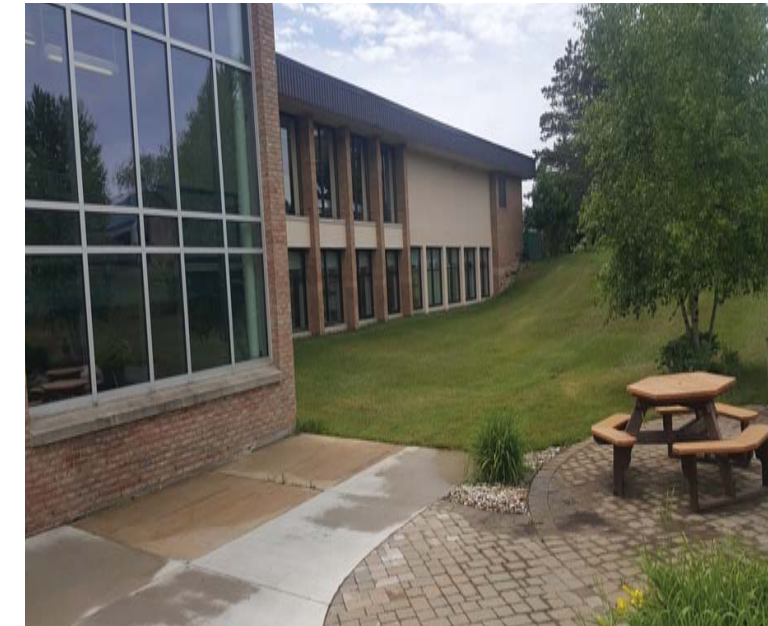
Multi-Media Resource Center RENOVATION OF FORMER STUDENT CENTER CAFETERIA

With the renovation and addition to the Student Innovation Center (the former library) inclusive of food service and dining, the renovation of the former Iron Horse Cafe and vacated Student Services areas would be planned for a new Multi-Media Resource Center. To maximize use of space, natural light, and create an inviting atmosphere, a two-level space would be created to accommodate this new use. Existing elevators and stairs would be reused, and access from the space to the future exterior amphitheater and courtyard would expand student study spaces to the outside in favorable weather.

This transformation would include access to educational resources, existing and emerging technologies, and student study areas of various sizes and degrees of flexibility.

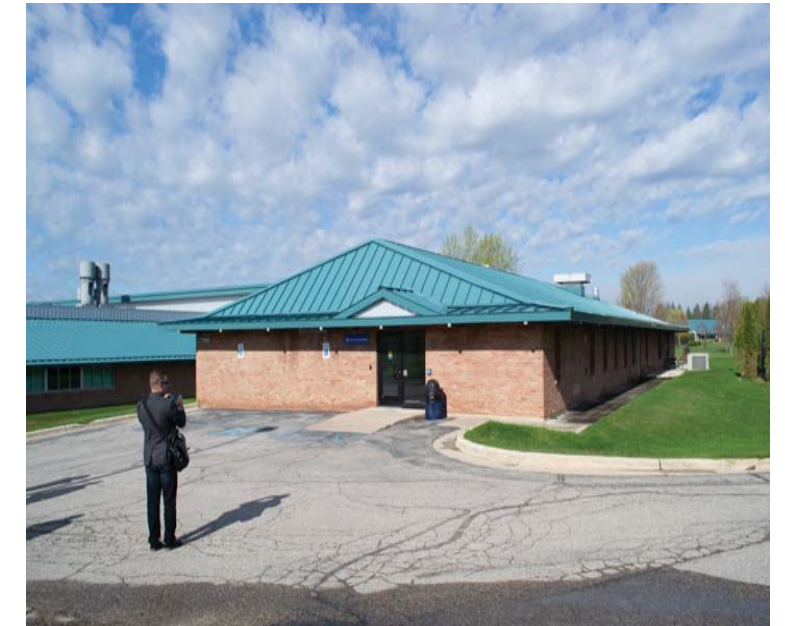
Maintenance and Technology Building Additions

Renovation and expansion to the existing Technology Building would include access upgrades, toilet room upgrades, student gathering areas, updated finishes, lighting and HVAC systems (heating, ventilation and air-conditioning), and a proposed 7,600 sf open space for flexible training and instruction for skilled trades, maker spaces, emerging technology testing and fabrication, and other uses. The spaces could be divided with racking systems that are movable to adjust to needed sizes of teaching areas. Overhead doors would allow for delivery and testing of any produced/built materials or systems. This space could incorporate natural light, advanced ventilation, and expandable power and data needs. A new parking area would be expanded for access to this building as well as the Health Education and Science Center.

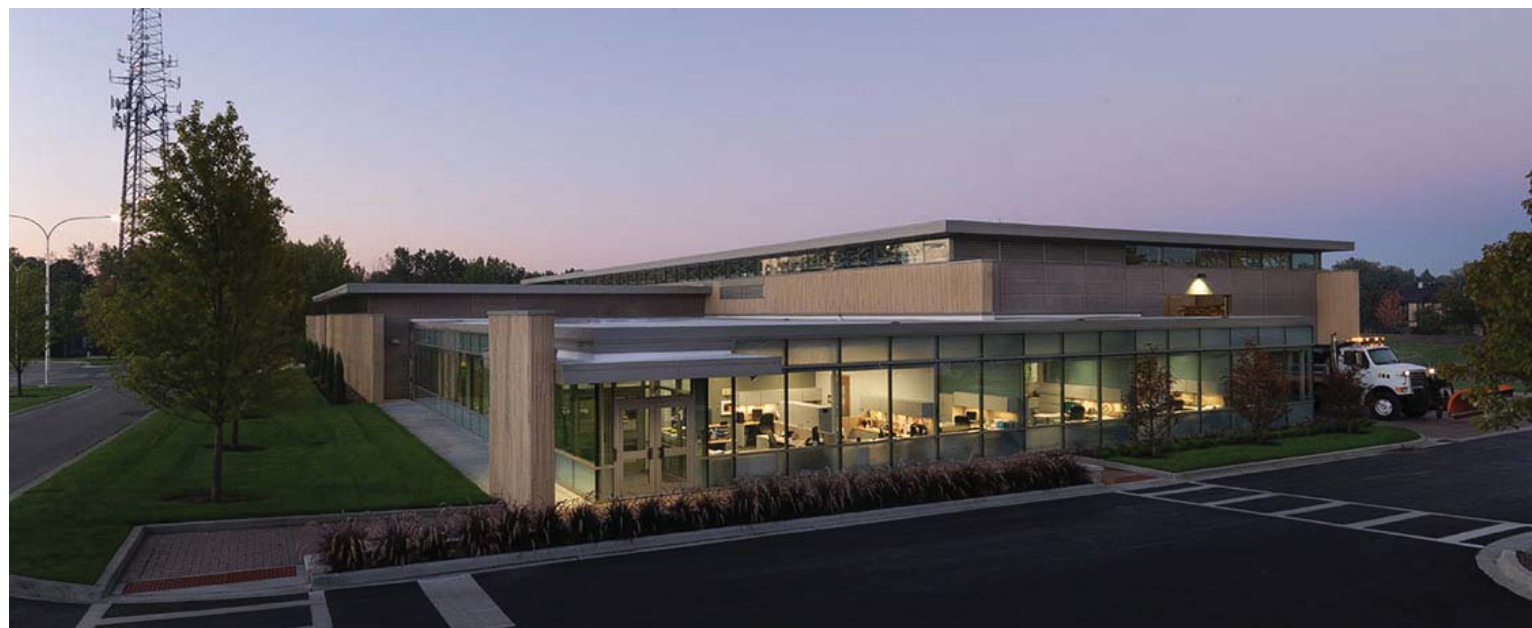
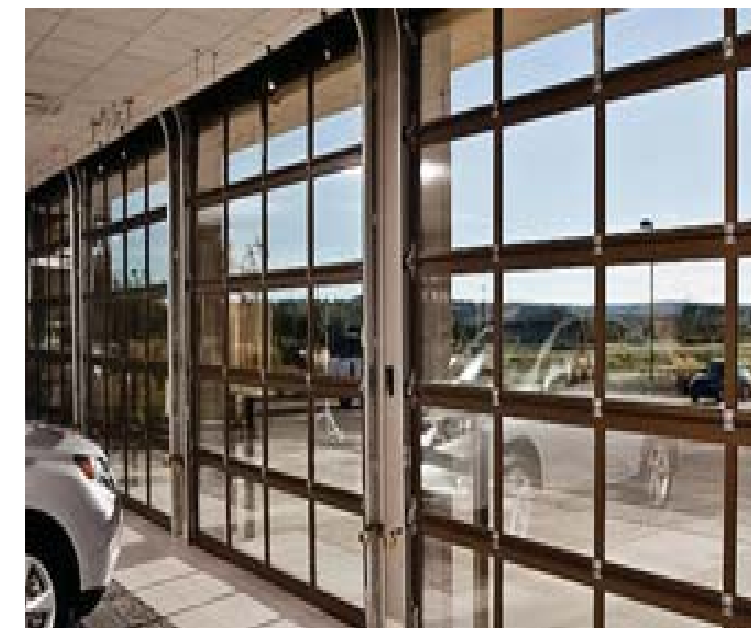
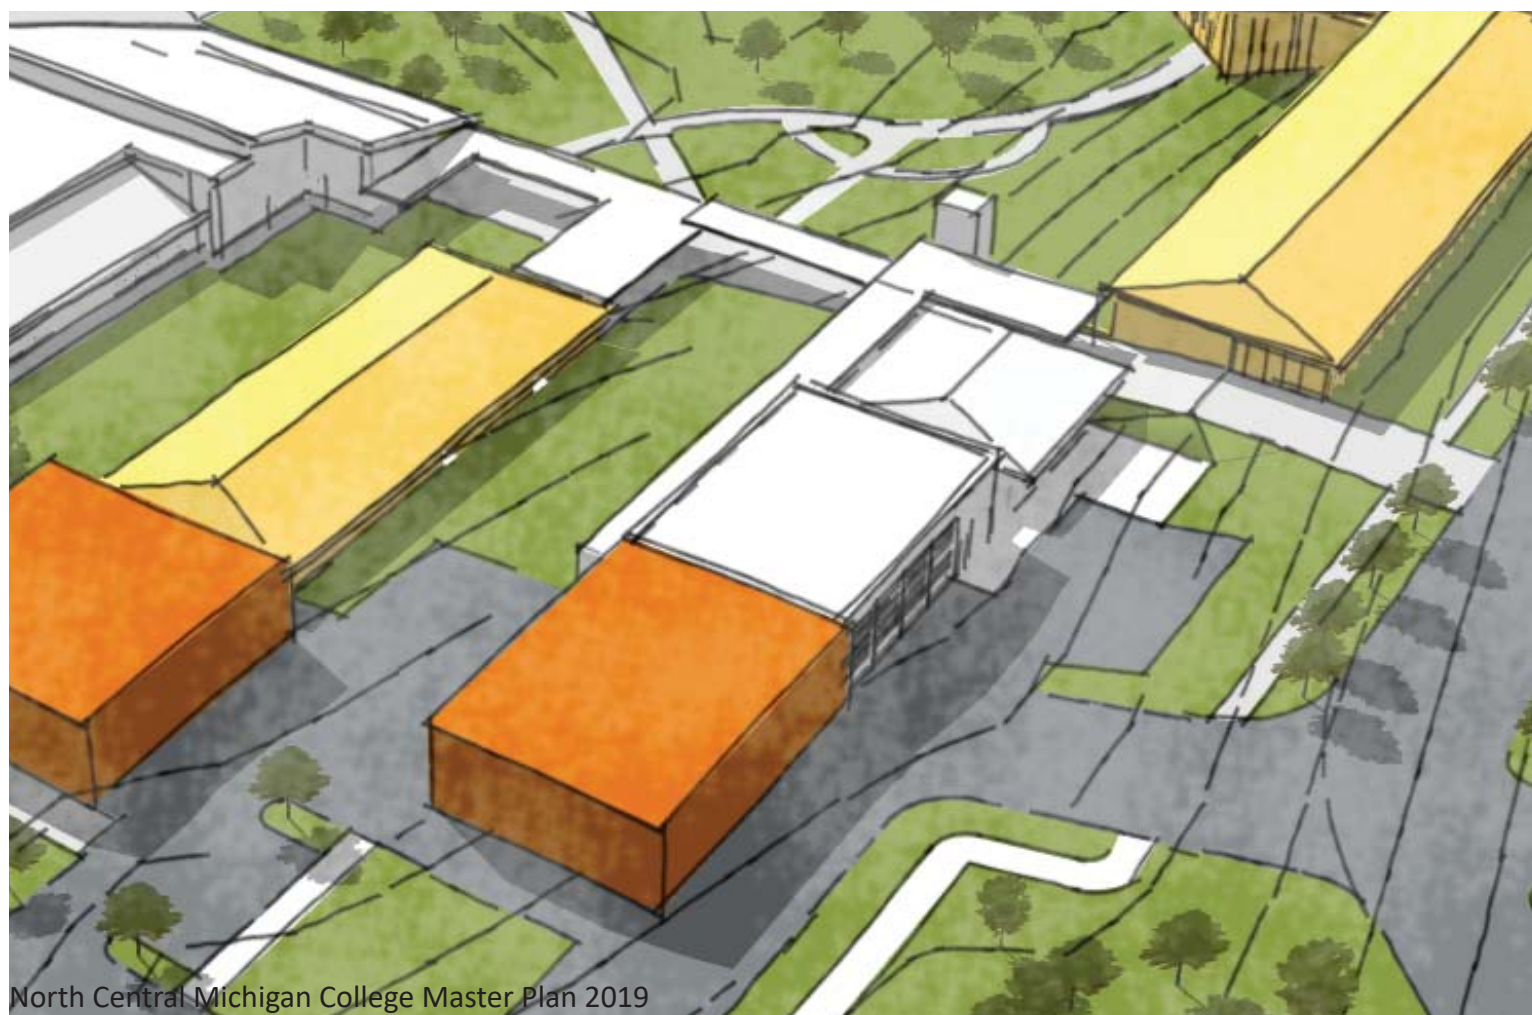
Maintenance Building Addition

The renovation and expansion of the Maintenance Building would provide needed additional pull-thru service bays to support campus maintenance, as well as provide indoor teaching space for courses based around the use of vehicles such as ambulances and fire trucks. Space would also be available for storage and on-site use of the mobile Fabrication Lab classroom.

It is recommended that the design be attractive and functional, since the placement is somewhat prominent to the east entry of Atkins Road. The expansion would include areas for vehicle wash bays, and incorporate a pull through design with overhead doors on two sides. This would reduce damage to the vehicles and allow for a double stacking of vehicles within the structure.

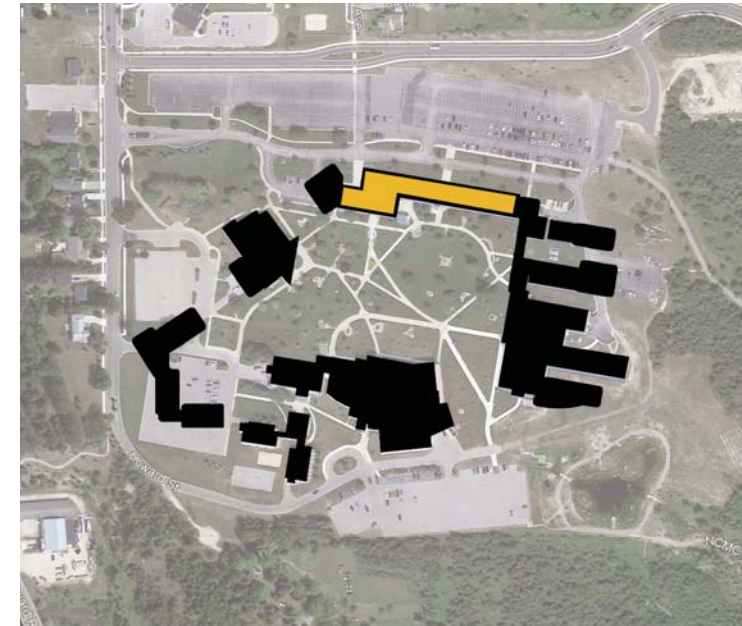
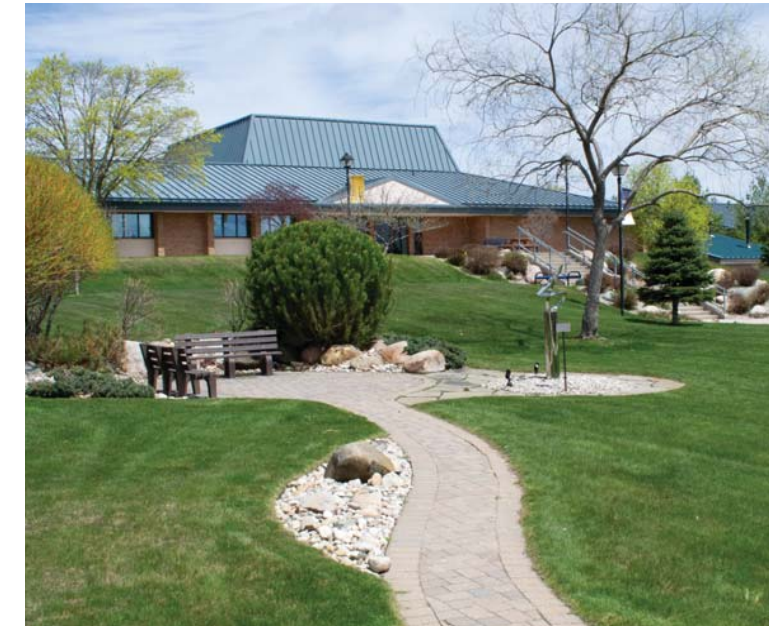
Administration/Classroom Building OFFICE + CONFERENCE AREA RENOVATION

The proposed office and conference room renovations would enlarge and aesthetically enhance the various instructor offices. The concept proposed would enlarge offices and place a study/conference room between the offices for shared use. This would accommodate student-instructor meetings, tutoring, and collaboration. This concept could occur on both levels as further defined by NCMC and staff.

It is suggested that this concept also be utilized for University Centers, and that more natural light be introduced with light wells from upper to lower levels and more glass along corridors.

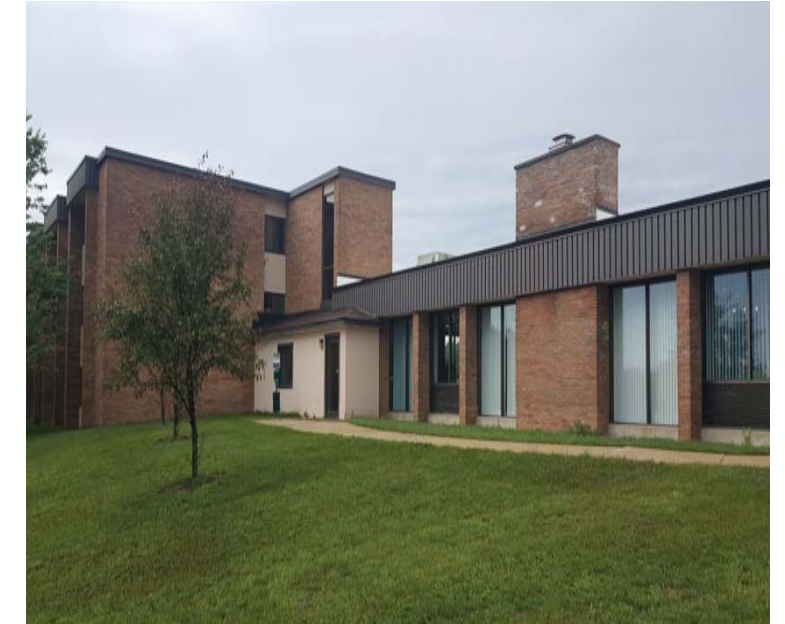
Residence Hall Renovation

The existing Residence Hall received many comments and suggestions for improvement from the students and staff. It is recommended that aesthetic and functional renovations be introduced to attract more students who want or need to live on campus (local, regional and international student exchanges). The renovation would include interior cosmetic upgrades with durable flooring, bathroom remodeling with new fixtures, new lighting, added power, larger operable windows, air conditioning (chilled water loop extended to the housing units) and enhanced ventilation. New energy efficient lighting would replace existing.

Two existing rooms per floor would be combined and renovated as attractive gathering/study spaces that may incorporate small kitchen areas. Added study rooms would be placed at the ends of the buildings to take advantage of views and natural light.

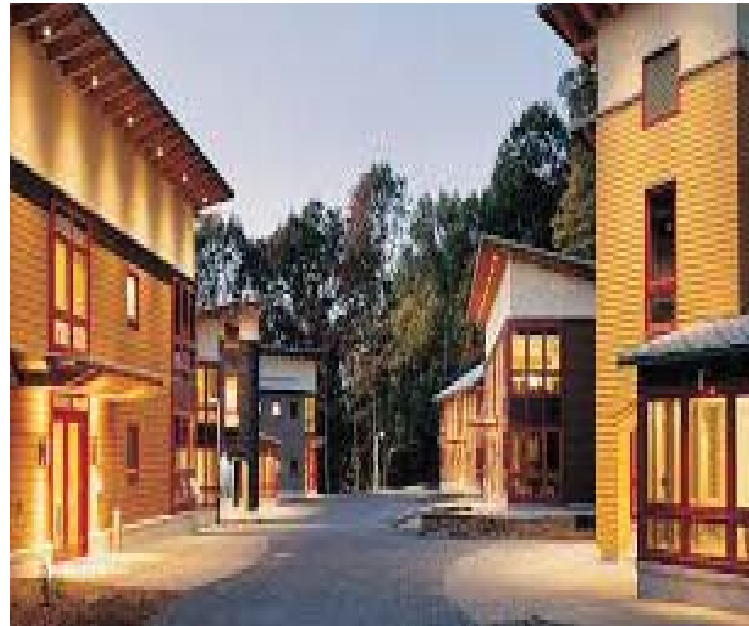
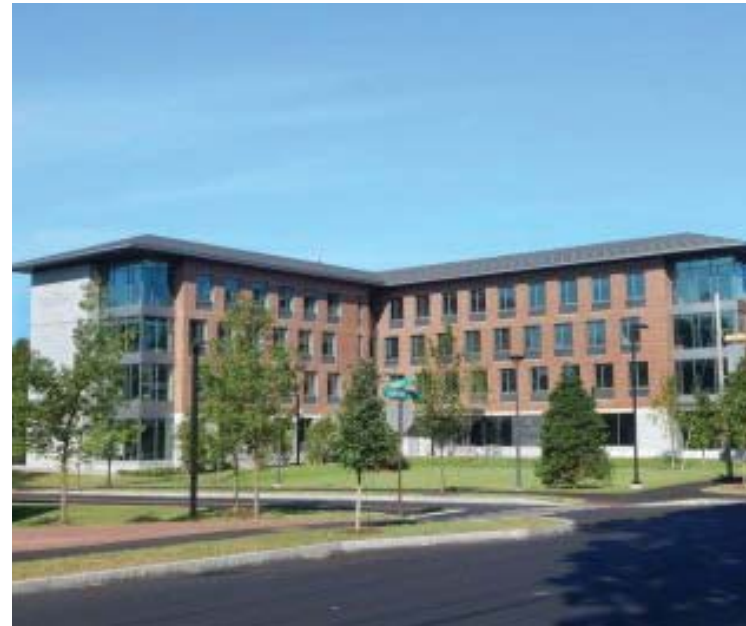
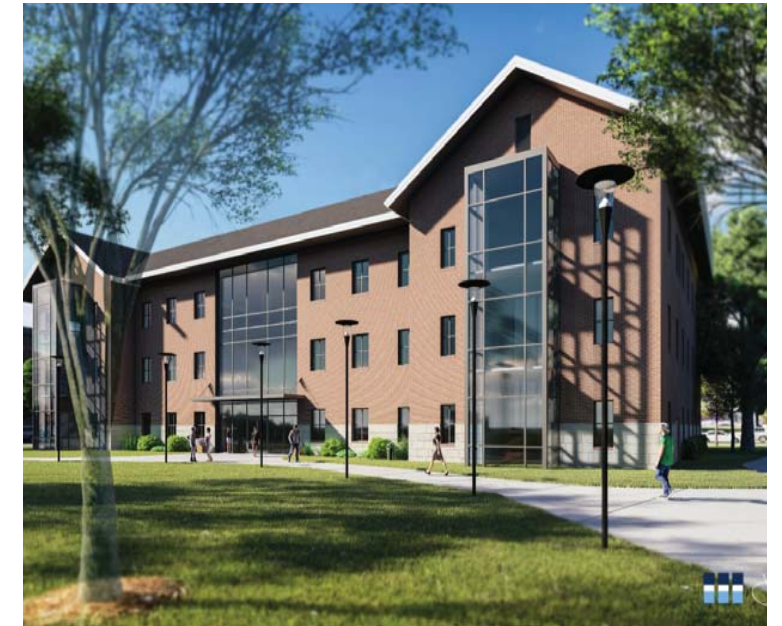
New Residence Hall - Phase 1

UNIT AREA: 924 SF

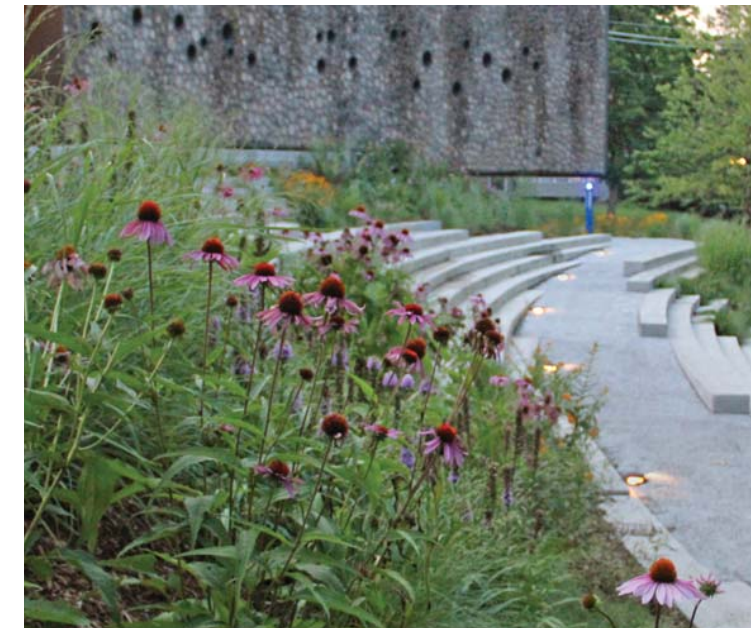
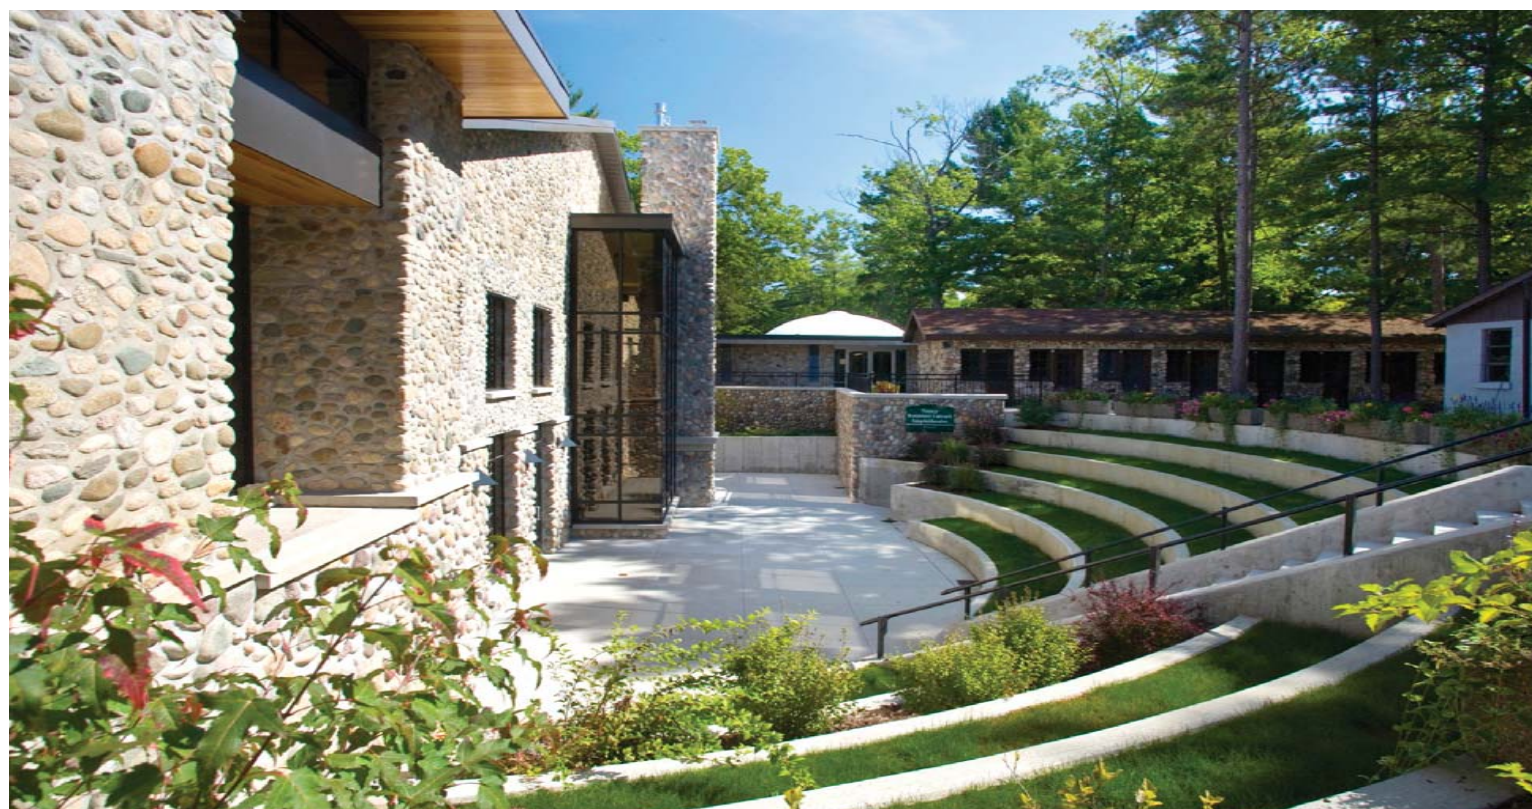
Amphitheater

With the degree of grade changes and topographical levels, there is an opportunity to sculpt a tiered amphitheater into the hill just south of the Student Innovation Center (former Library). This multi level seating area would be designed to also serve as a barrier free ramping design that enables physically challenged individuals to get from the upper level of the Student Innovation Center to the existing Residence Hall and new Multi-Media Center (former Student Center Cafeteria). It would provide outdoor performance space, study space and courtyard space proximate to heavily accessed student spaces.

This placement would have limited effect on the existing sculptures placed in the central gardens, and is proximate to summer parking areas for outdoor campus events.

For winter months, a snow melt system is recommended to provide for all-season use and access.

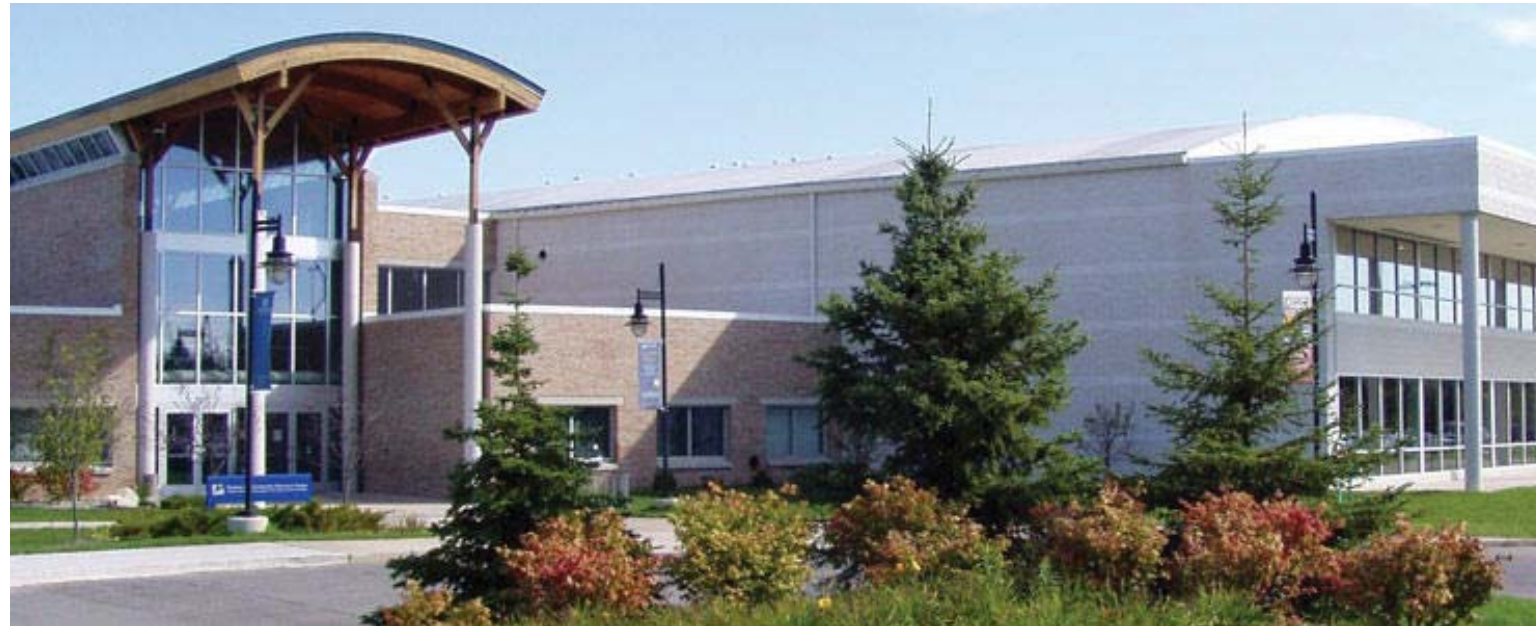
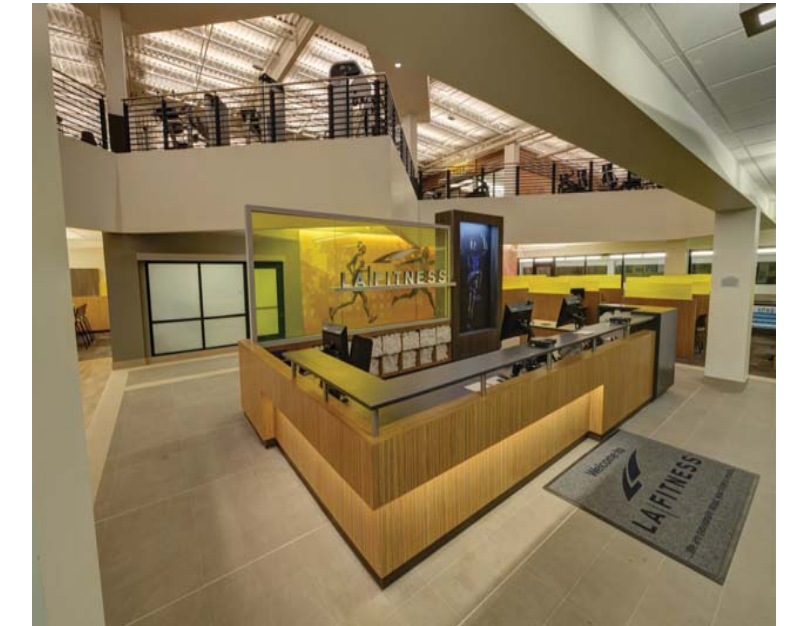
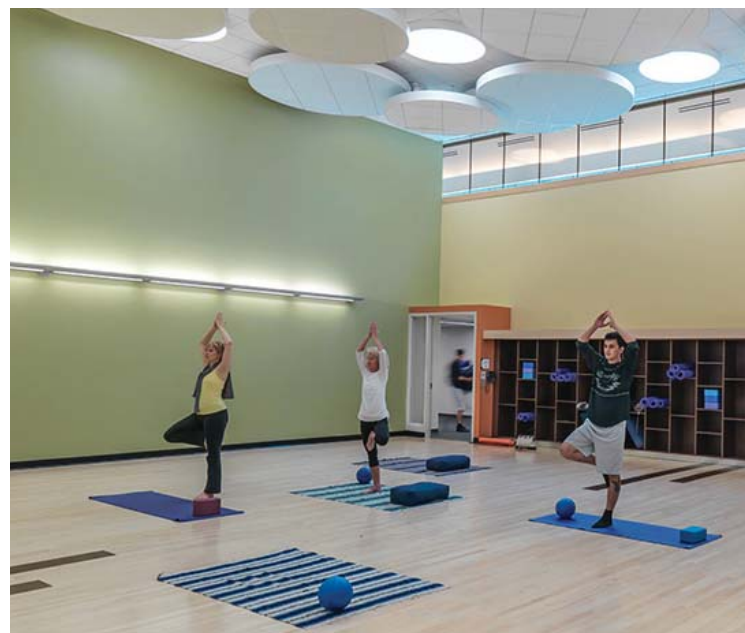
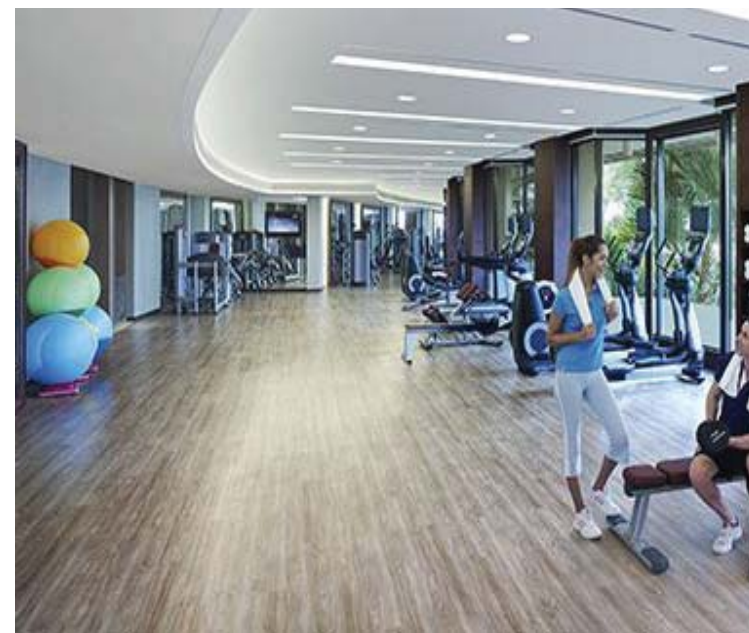
SCRC Renovation and Addition

Proposed renovations for the Student and Community Resource Center (SCRC) include cosmetic upgrades, better utilization of space, a designated Community entrance on the east and a designated Student entrance on the west side of the facility. The community entry would require an addition to the building.

Added physical education classrooms would be identified in areas adjacent to the main concourse on the main level (food service area) and on the upper level. Upper level catwalk space would be increased to provide added study enclaves adjacent to window areas.

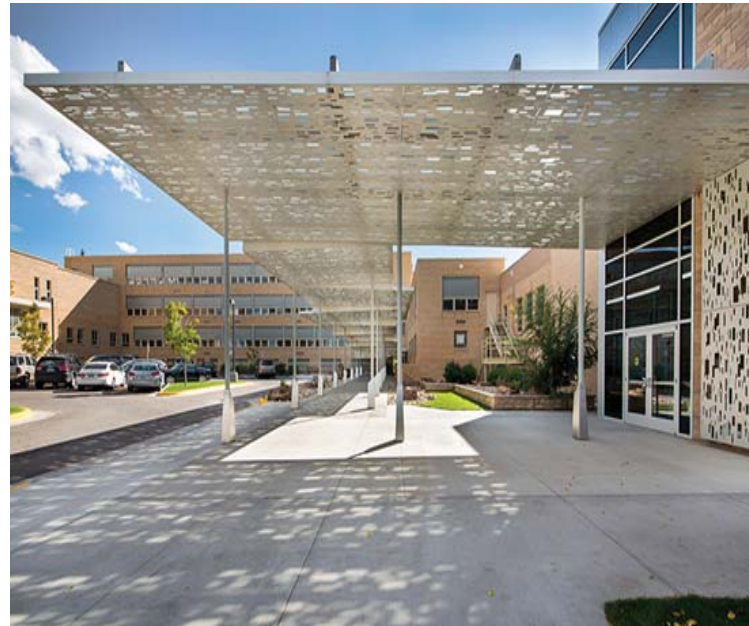
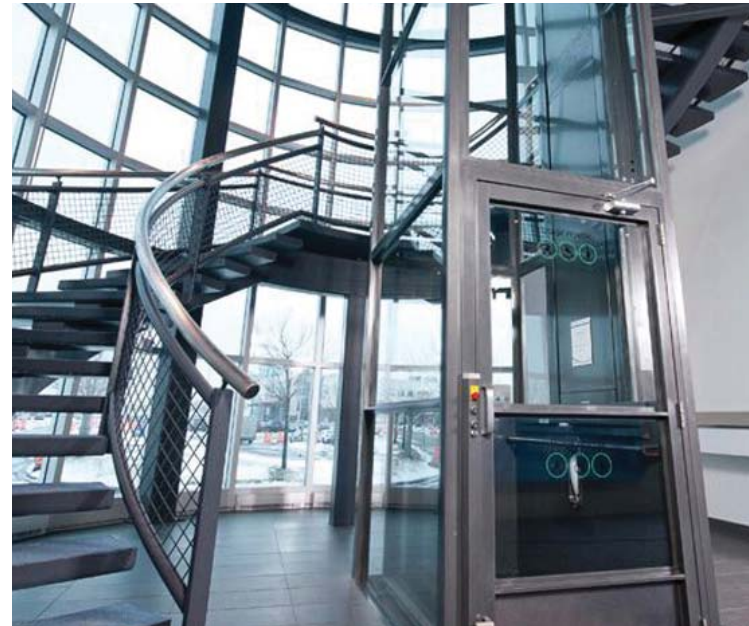
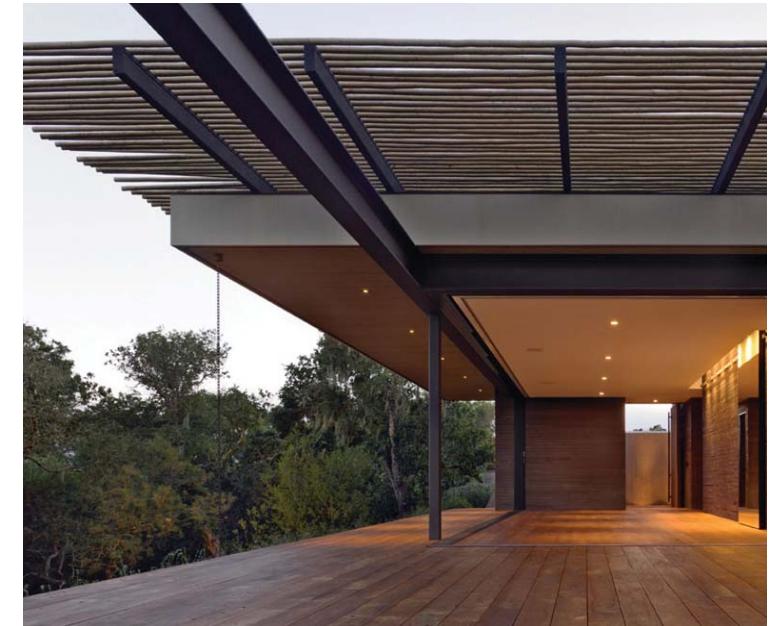
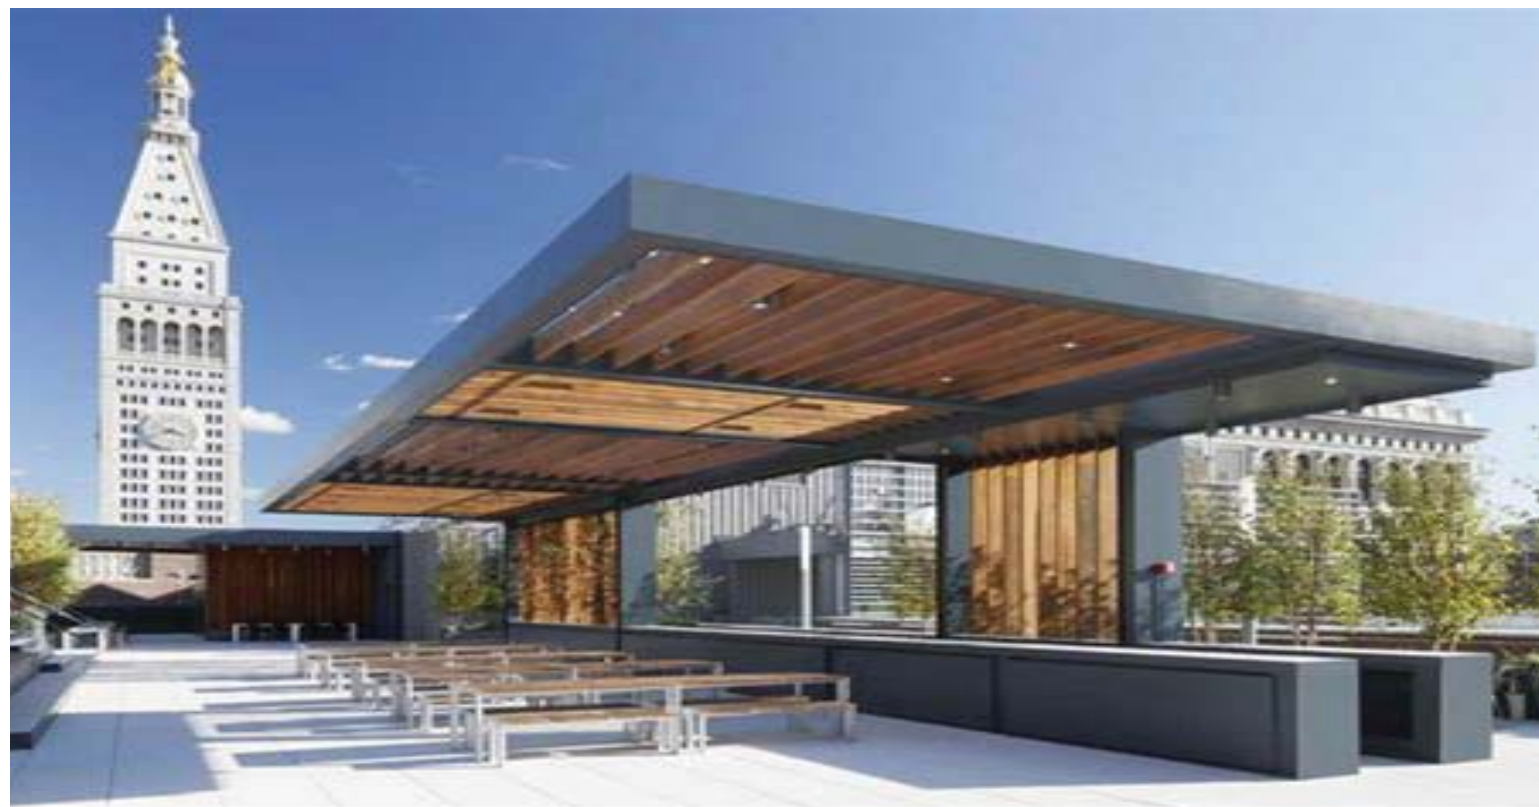
Northeast Covered Connector

The northeast entry point to the campus is heavily used by students who park in the north lots and attend classes in the Technology Building, Health Education and Science Center, and Administration/Classroom Building. This area is exposed to north winds and snow which make this access dangerous during the winter season.

Four educational buildings use this circulation route for access. The grade slopes significantly from Parking Lot 1 to the north entrance of the HESC, with a drop in elevation of about 14' over the length.
