NORTH CENTRAL MICHIGAN COLLEGE **2019 MASTER PLAN**

2019 -2023

October 29, 2019

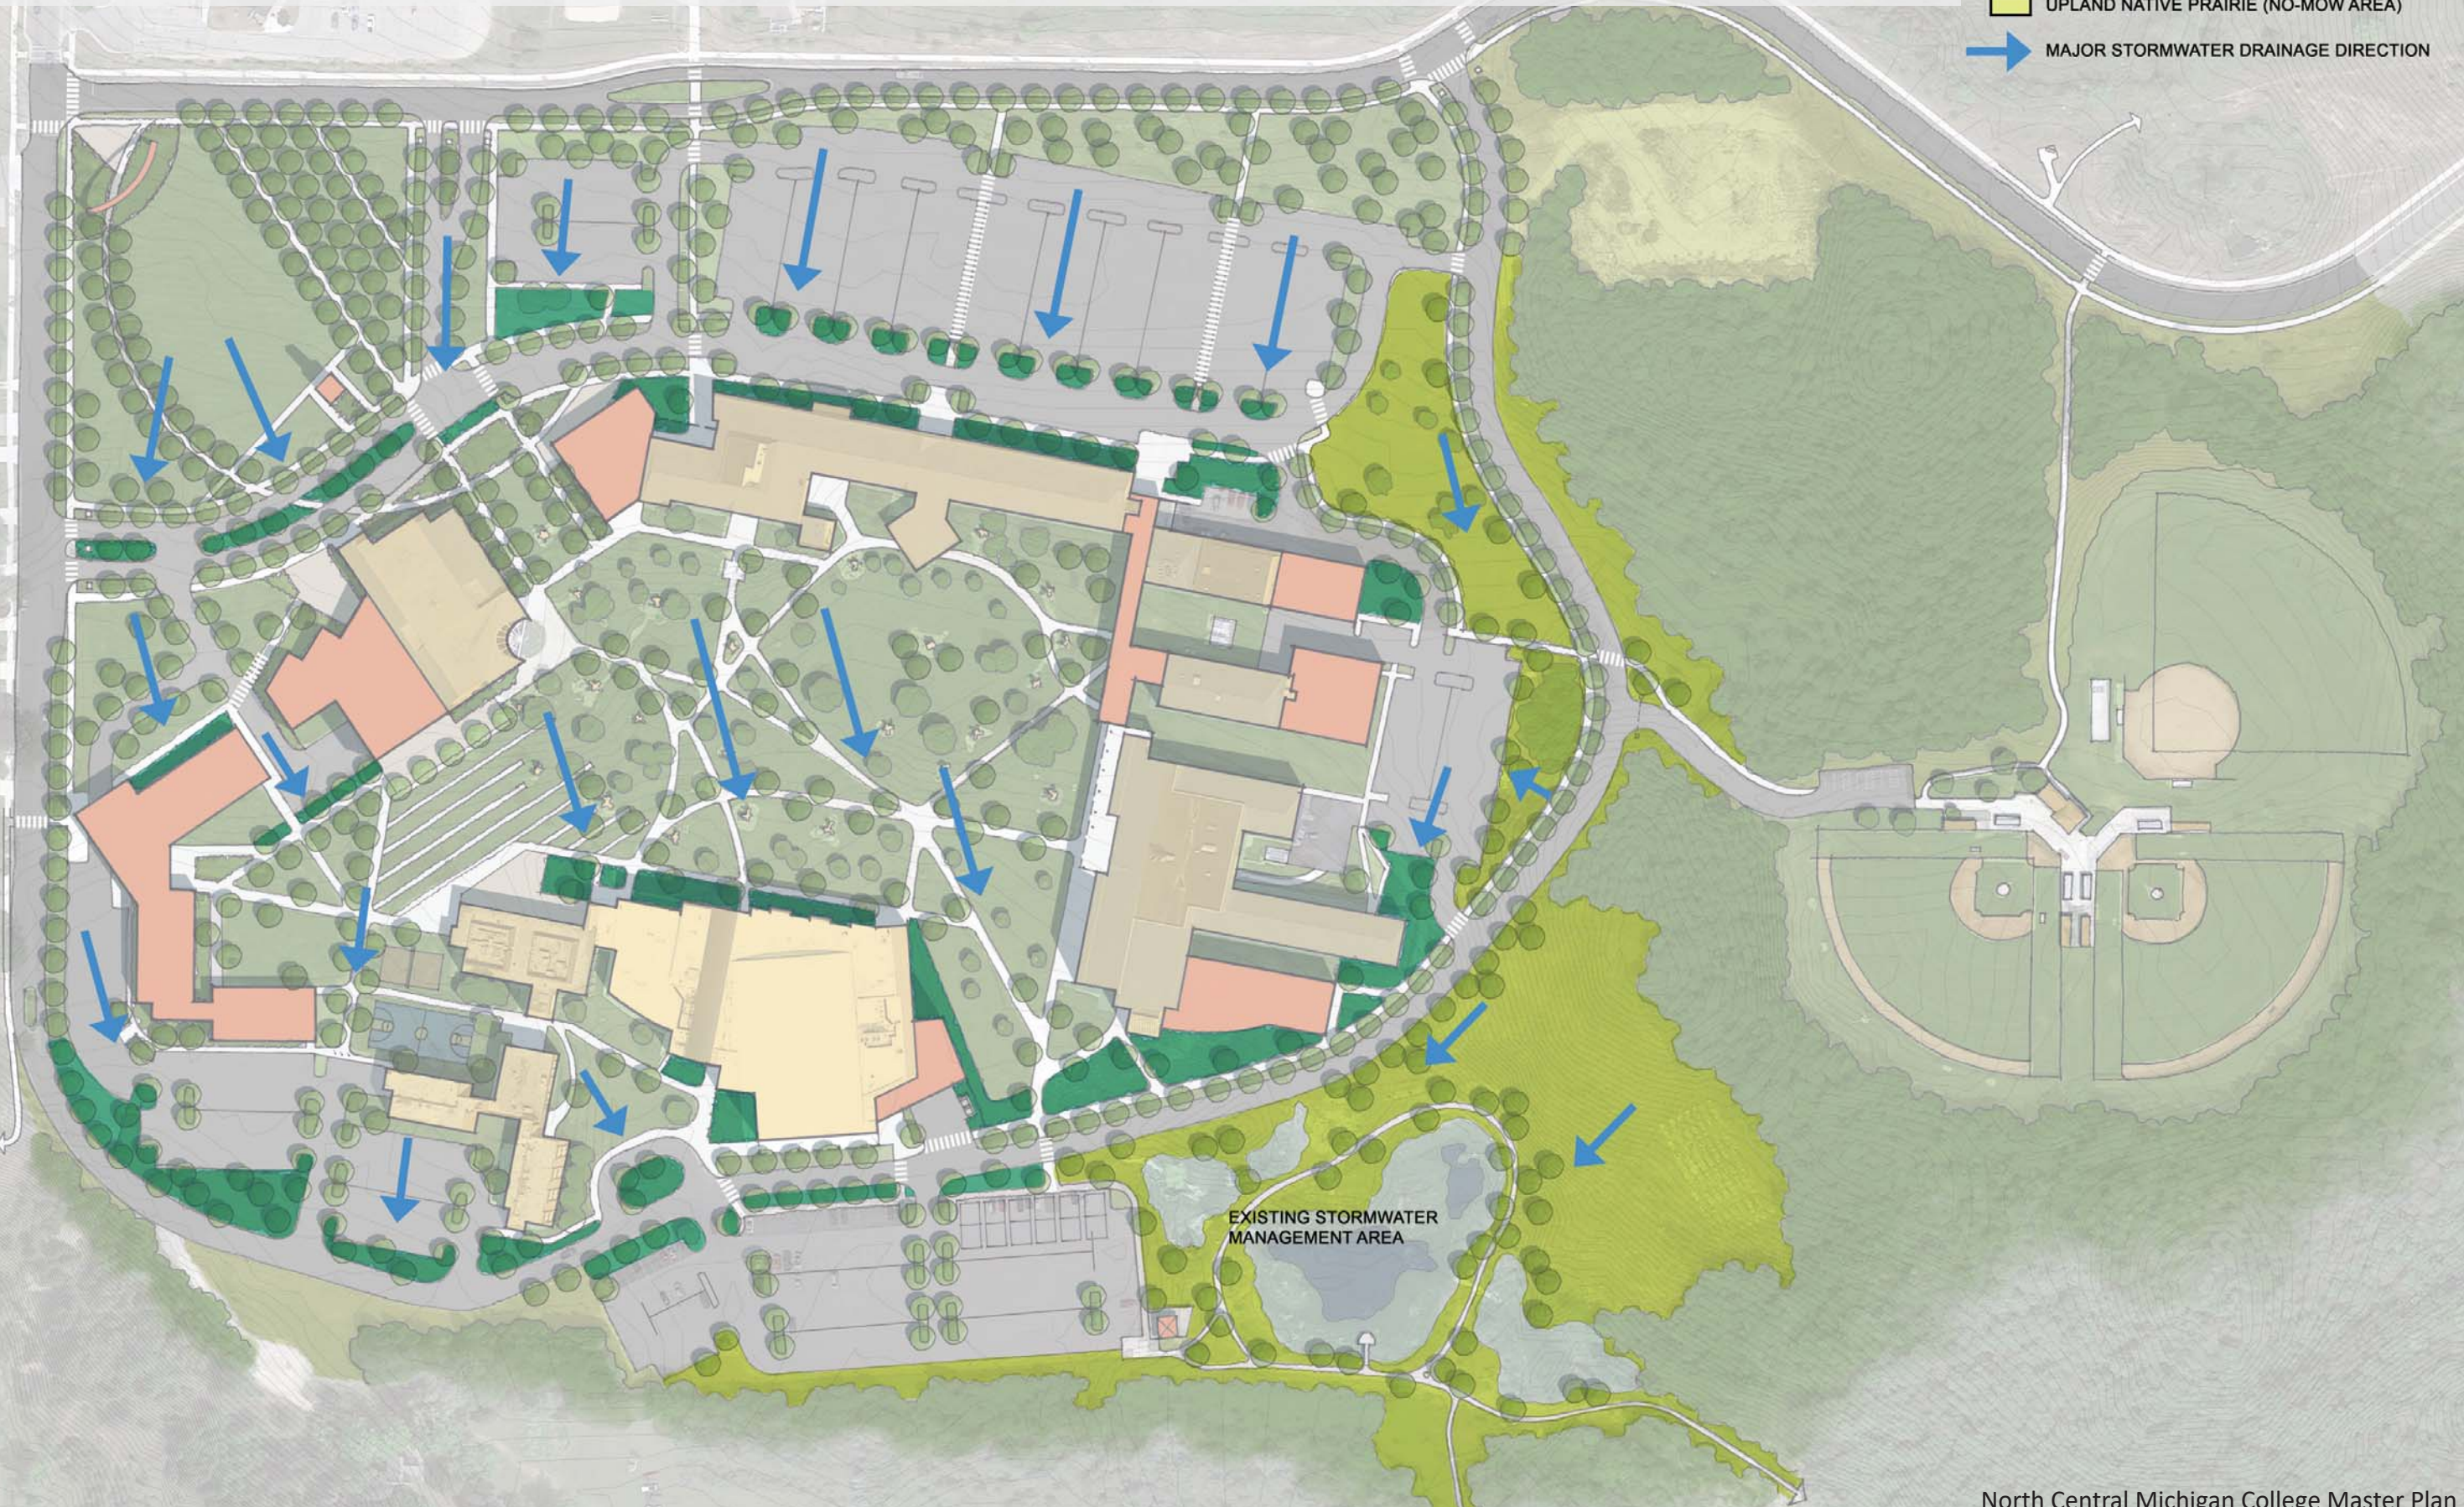
Site Green Infrastructure Plan

- LEGEND**
- BIO-INFILTRATION (BIOSWALES AND RAIN GARDENS)
 - UPLAND NATIVE PRAIRIE (NO-MOW AREA)
 - MAJOR STORMWATER DRAINAGE DIRECTION

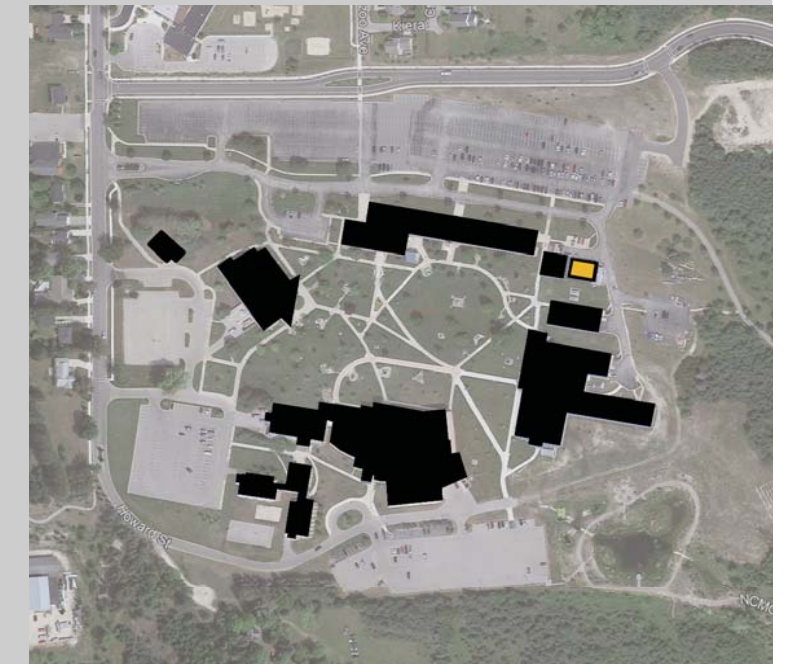
Maintenance Building: Building Component Life Expectancy: Mechanical

Building Square Footage = 3,400 square feet
Building Built in 1973
